*Living Shoreline Sea Level Resiliency:
Performance and Adaptive
Management of Existing
Breakwater Sites*

Living Shoreline Sea-Level Resiliency: Performance and Adaptive Management of Existing Breakwater Sites

Year 2 Summary Report

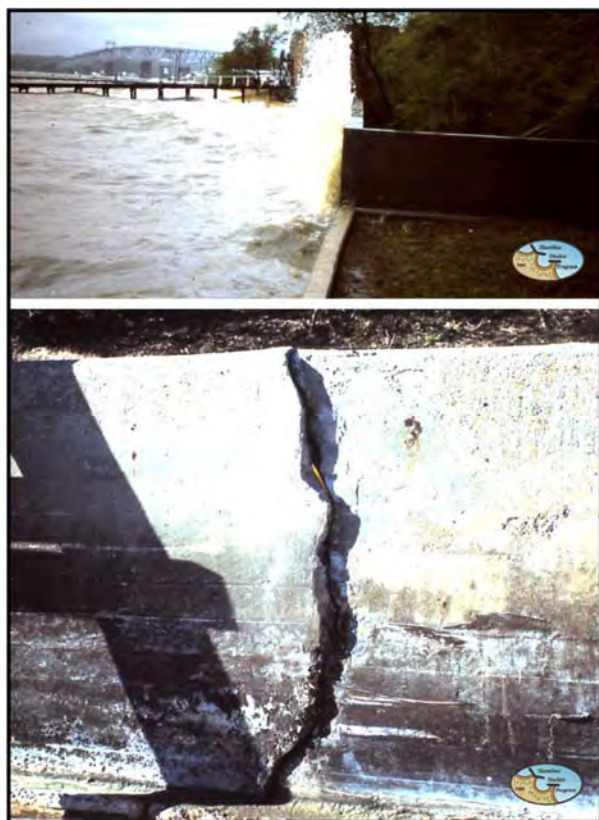
Figure 4-1-5. Top: During the April 1978 northeast storm, waves directly impacted the seawall because VIMS had no sandy beach in front. Bottom: The storm damaged the seawall.

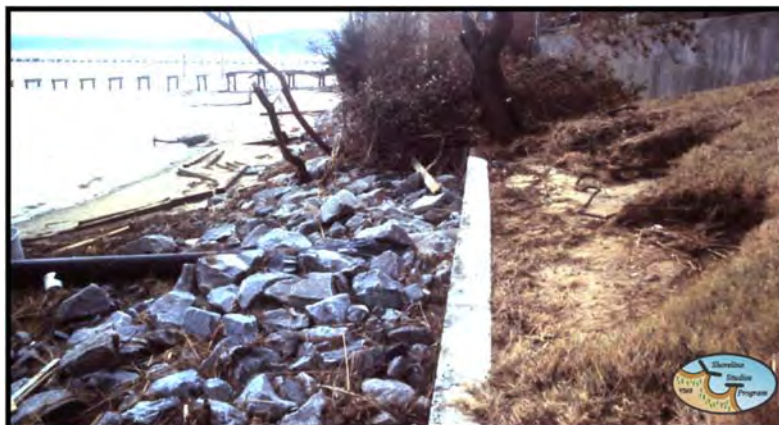
Figure 4-1-7. In 2003, Hurricane Isabel greatly damaged many areas along the VIMS shoreline. Wave action overtopped the seawall and revetment cutting into the bank.

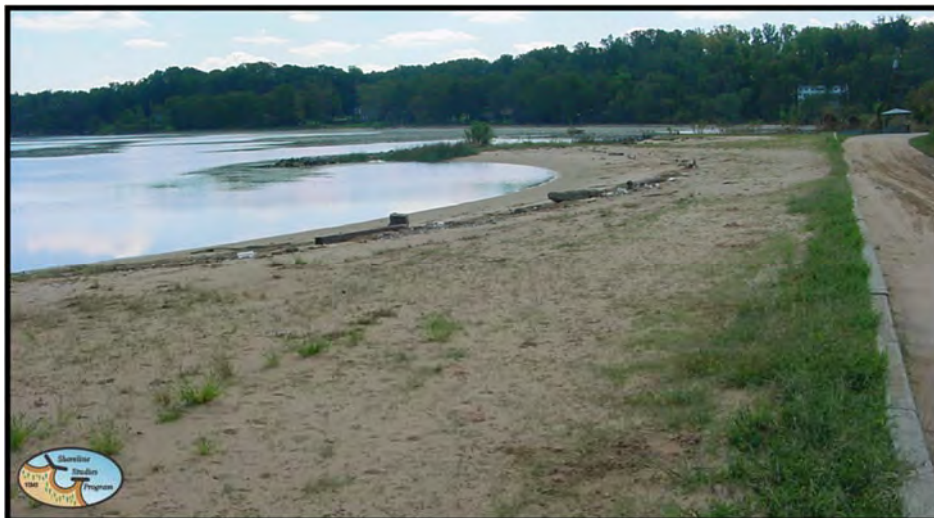
Though the storm surge topped the system during Hurricane Isabel and sand washed over the jersey wall onto the road (Figure 4-3-3), no extreme changes in topography were measured indicating that overall, the breakwater system remained stable during the storm (Hardaway *et al.*, 2006). The beach along Aquia Landing has been relatively unchanged since Hurricane Isabel. The shore planform has remained relatively stable since Isabel except for the thinning of tombolo attachments which have not impacted the beach and backshore (Figure 4-3-4). A wide recreational beach occurs at the site. The tombolos are heavily vegetated and a great deal of SAV occurs in the nearshore. Some variation has occurred in the position of MHW over time (Figure 4-3-5), but it has been relatively minor. The position of the embayments post-Hurricane Isabel shoreline on October 30, 2003, were slightly shifted due to wind and wave action during the storm. The 2013 and 2019 high water shorelines are similar although the 2019 tends to be riverward of the 2013. The tombolo at breakwater 4 has lost its attachment over time as the structure itself sank. Though heavily vegetated, the breakwater 4 tombolo is lower than the others (4-3-6).

Figure 4-3-3. Aquia Landing shoreline on 30 September 2003 post Hurricane Isabel. Though sand washed over the jersey wall, overall the system is intact.

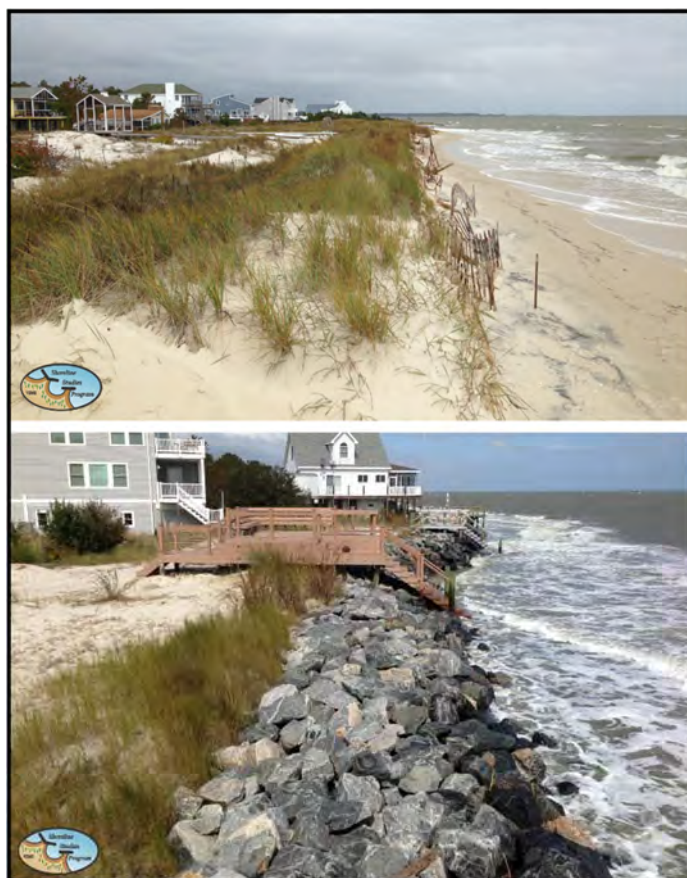
Figure 4-5-4. Top: Northern section of the Bavon reach during a high water event on 5 October 2015. The wide dunes protect the houses. Bottom: a revetment was constructed because the dunes had eroded along the southern section of the reach but no beach

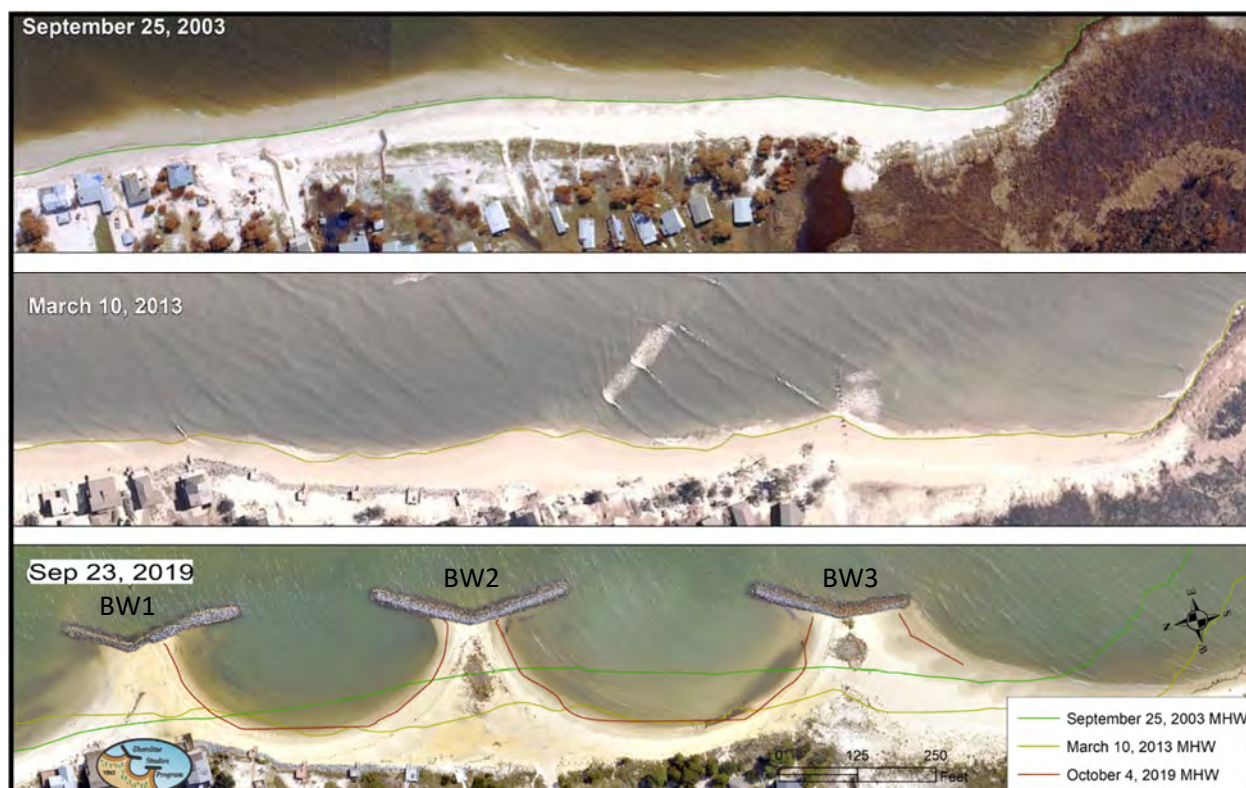
The southern section of the Bavon reach has been eroding rapidly. Between 2003 and 2013, the shoreline significantly retreated (Figure 4-5-6). Though high water advanced along most of this shoreline between 2013 and 2019 due to the construction of the breakwaters, its

Figure 4-5-6. Shoreline change between 2003 and 2019 at the Yorktown breakwaters. The 2003 and 2013 shorelines are approximately mean high water based on the digitizer's best guess of the features shown on the aerial photo. The 2019 shoreline is from the survey data.

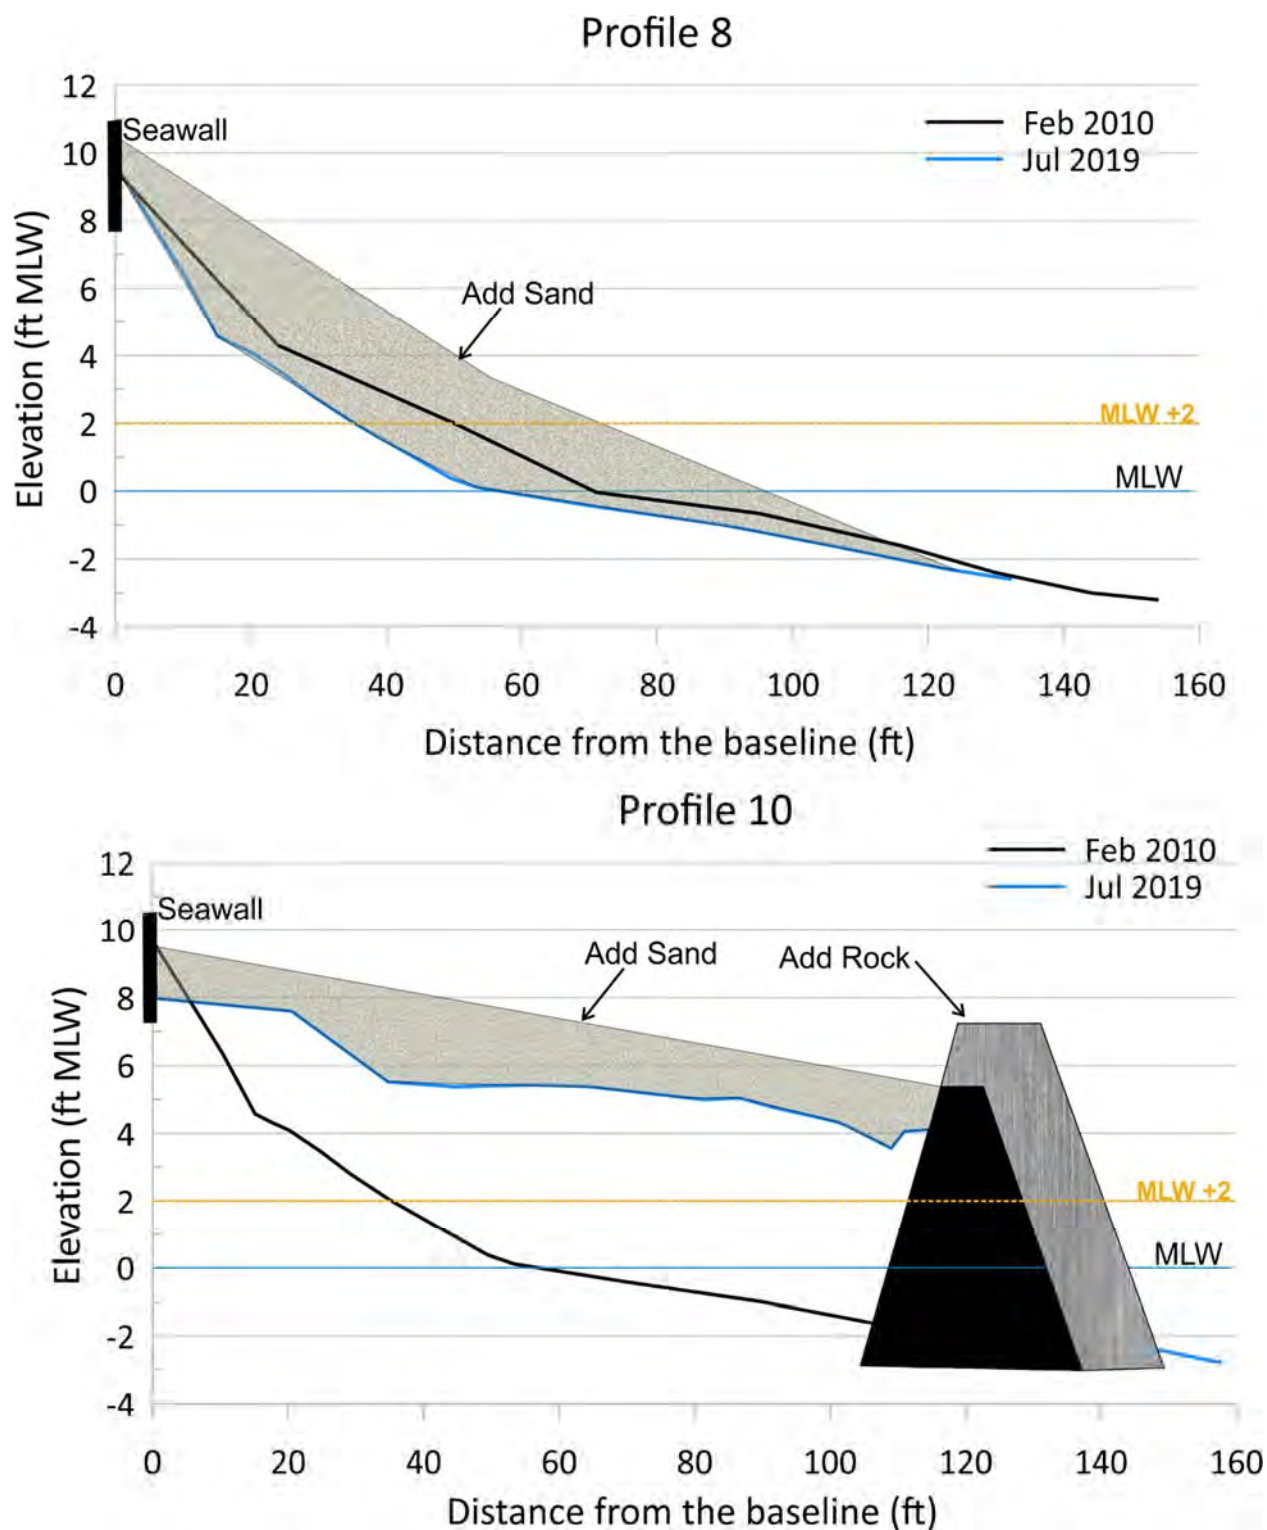
Figure 5-1. Selected cross-sectional profiles of survey data taken at VIMS in 2010, pre-project installation and 2019. The +2 ft MLW depicts the SLR scenario. Rock and sand can be added to the system to adapt to rising sea level to ensure resiliency of the overall system. The 2010 survey data provided by VHB, Inc.

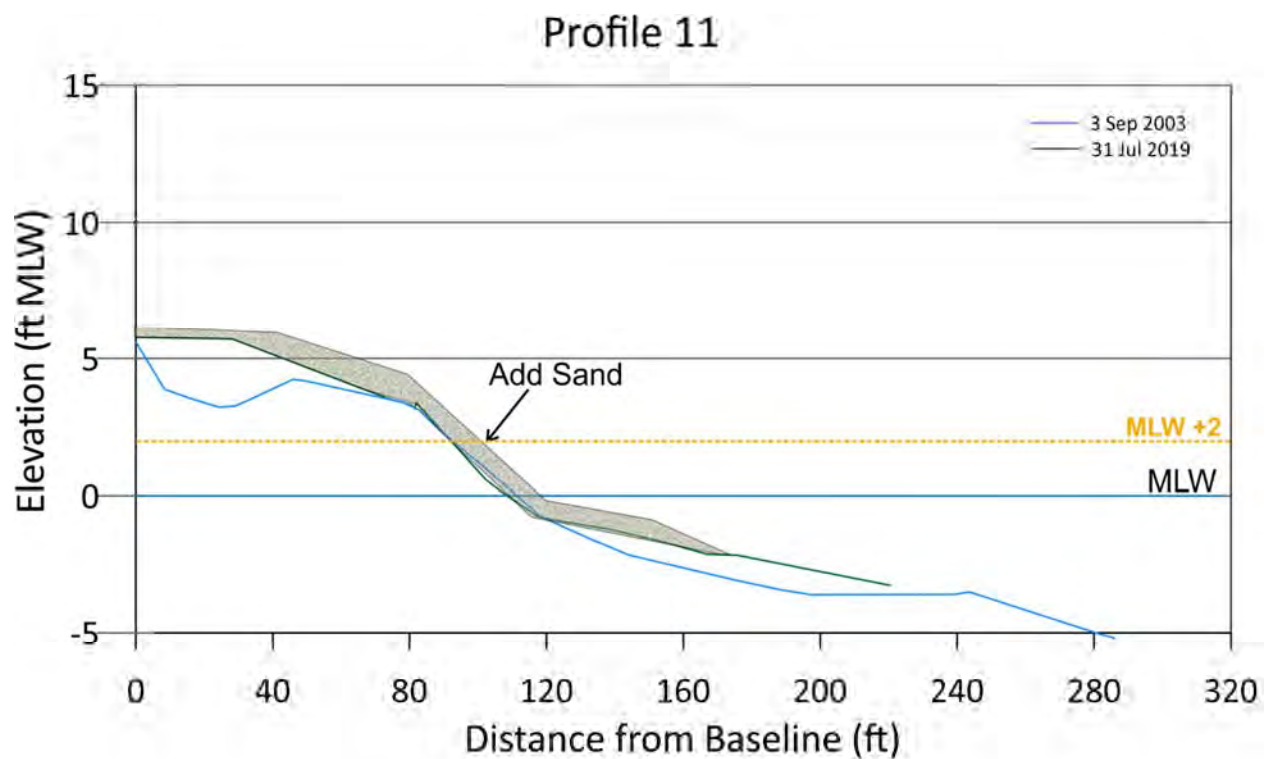
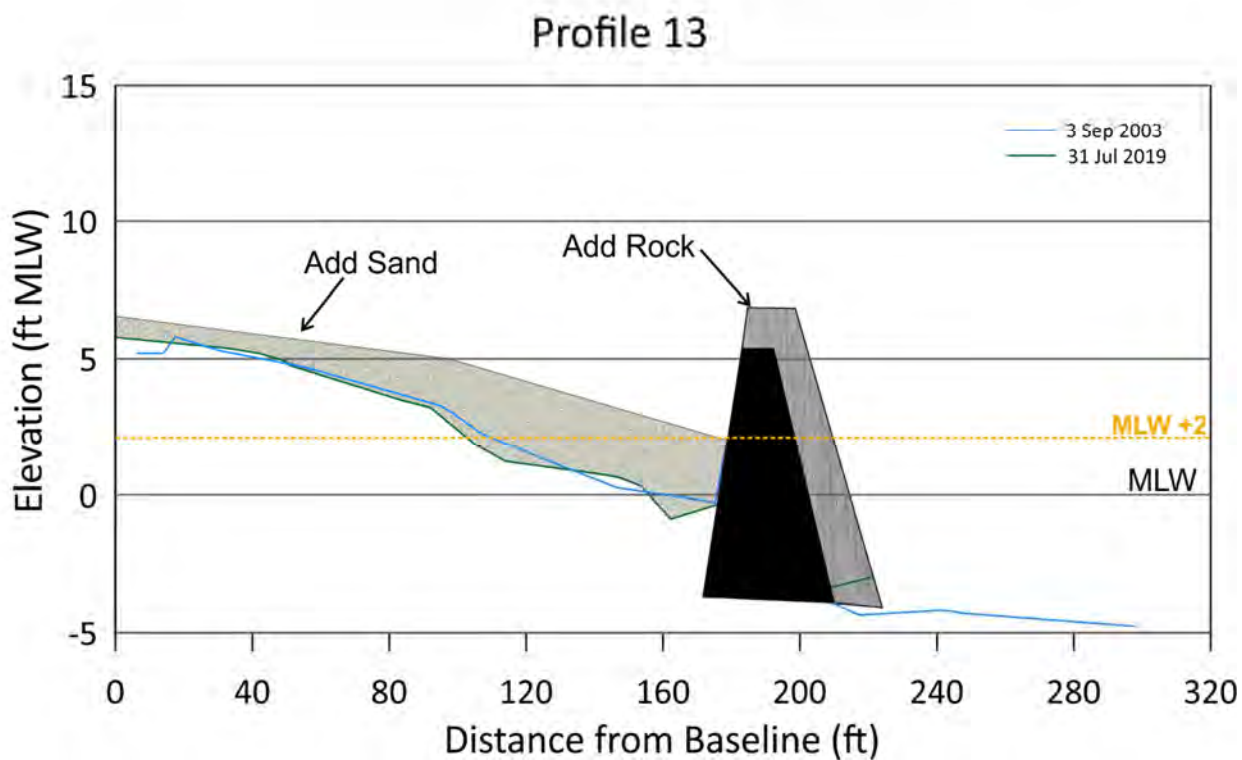
Figure 5-2. Selected cross-sectional profiles of survey data taken at Yorktown in 2003, Post Hurricane Isabel and 2019. The +2 ft MLW depicts the SLR scenario. Rock and sand can be added to the system to adapt to rising sea level to ensure resiliency of the overall system.

At Yorktown, in addition to raising the backshore barrier, to address the 1 and 2 foot SLR by 2050, an increase in breakwater height is recommended (Figure 5-2). The new armor should be at least 2-3 feet higher to accommodate the required rock size which is 1 to 2-ton armor. Perhaps a more reasonable approach to raising breakwaters is to add rock blocks/rectangles along the crest. As an example, these would be on the order of 3x3x8 ft concrete structures that can weigh about 6 tons. Dimensions placement could vary. These would simply be placed along the top of each unit, and, although expensive to fabricate, it might be cheaper than adding and constructing additional armor layers. More sand will be required for the system as well. The shore planform can only adjust vertically with SLR unless the system is moved offshore. Moving the breakwaters offshore and adding much more sand might be cost prohibitive as the breakwater rock volume would increase and additional rock would be required. The high value of infrastructure behind Yorktown Beach as well as the economic value of beach usage make maintaining the beach important.

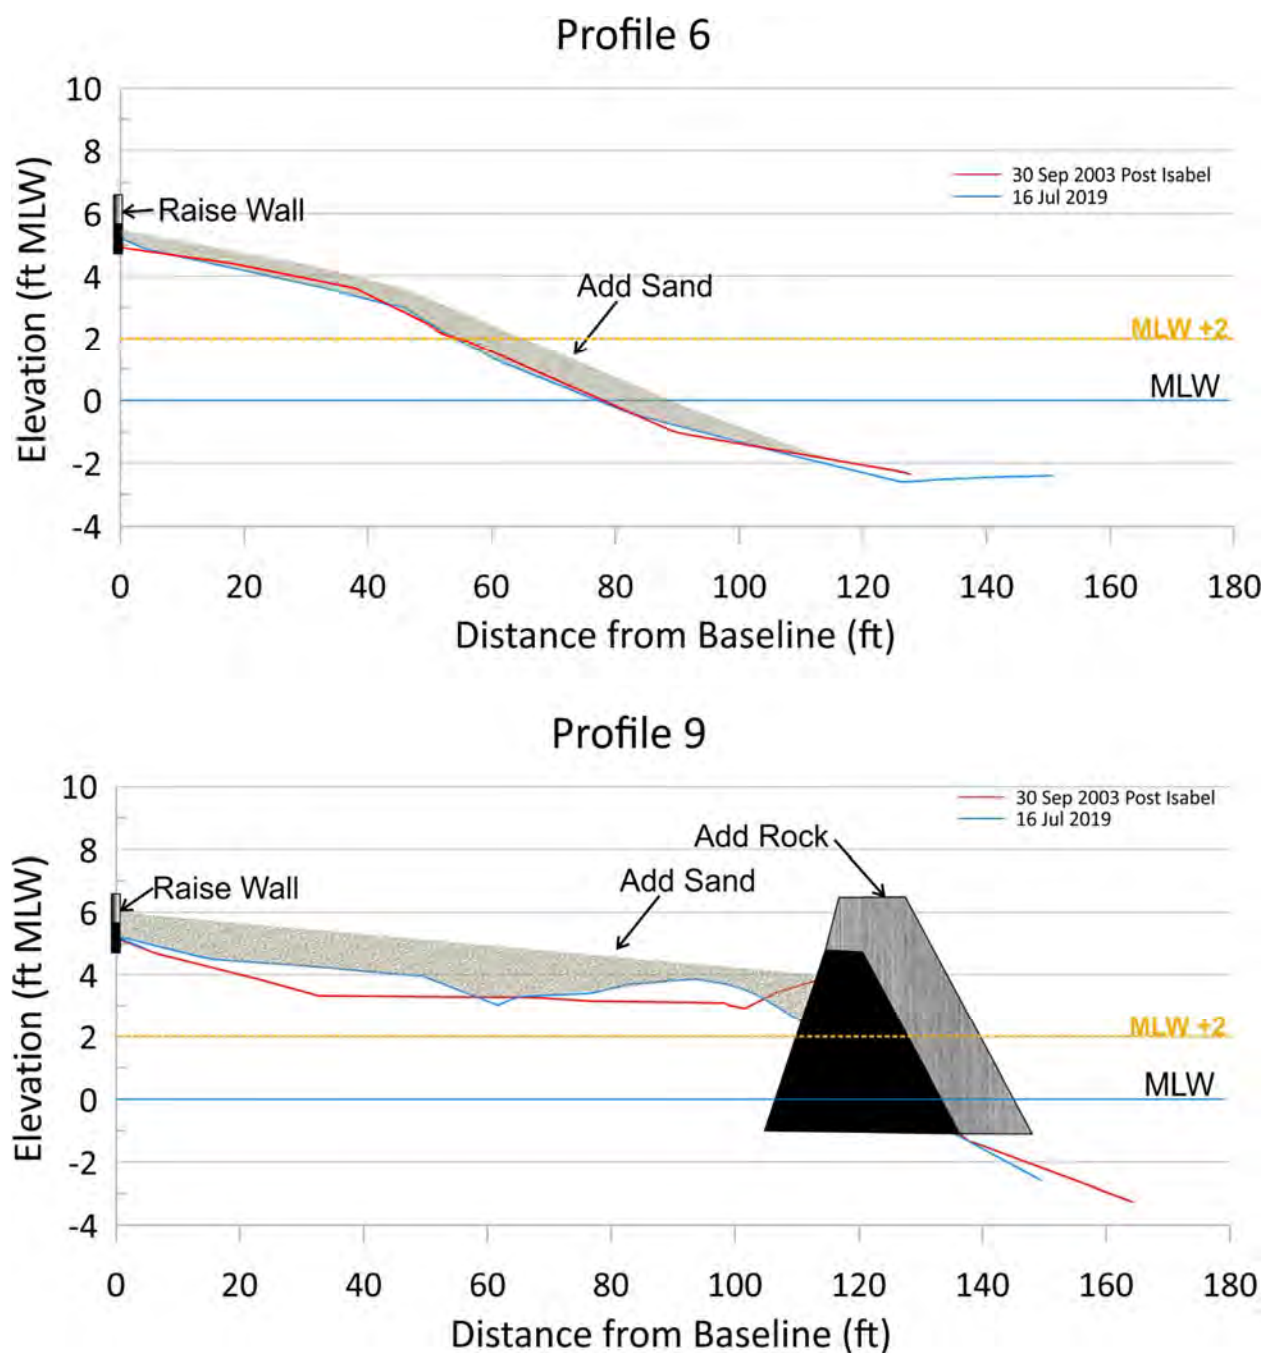
Figure 5-3. Selected cross-sectional profiles of survey data taken at Aquia Landing in 2003, Post Hurricane Isabel and 2019. The +2 ft MLW depicts the SLR scenario. Rock and sand can be added to the system to adapt to rising sea level to ensure resiliency of the overall system.

At sites that may experience the coastal squeeze scenario, the breakwaters may require an increase in elevation with additional rock and sand. Because sea level will be one to two feet higher, the beach barriers along Aquia Landing, Yorktown, and possibly VIMS will have to be raised as well. The VIMS seawall may be high enough to address the added volume of rock and sand that can be added to adapt to a rise in sea level (Figure 5-1). In addition, keeping the trees thinned to allow the beach system to be stabilized by marsh grasses is necessary to maintain the system. As noted in the earlier section, the bay at Profile 8 has moved landward slightly since pre-installation of the structures. This was due to placement of the structures and sand to minimize impacts to nearshore biologic experiments. However, the bay has reached a dynamic equilibrium and should maintain its shape.

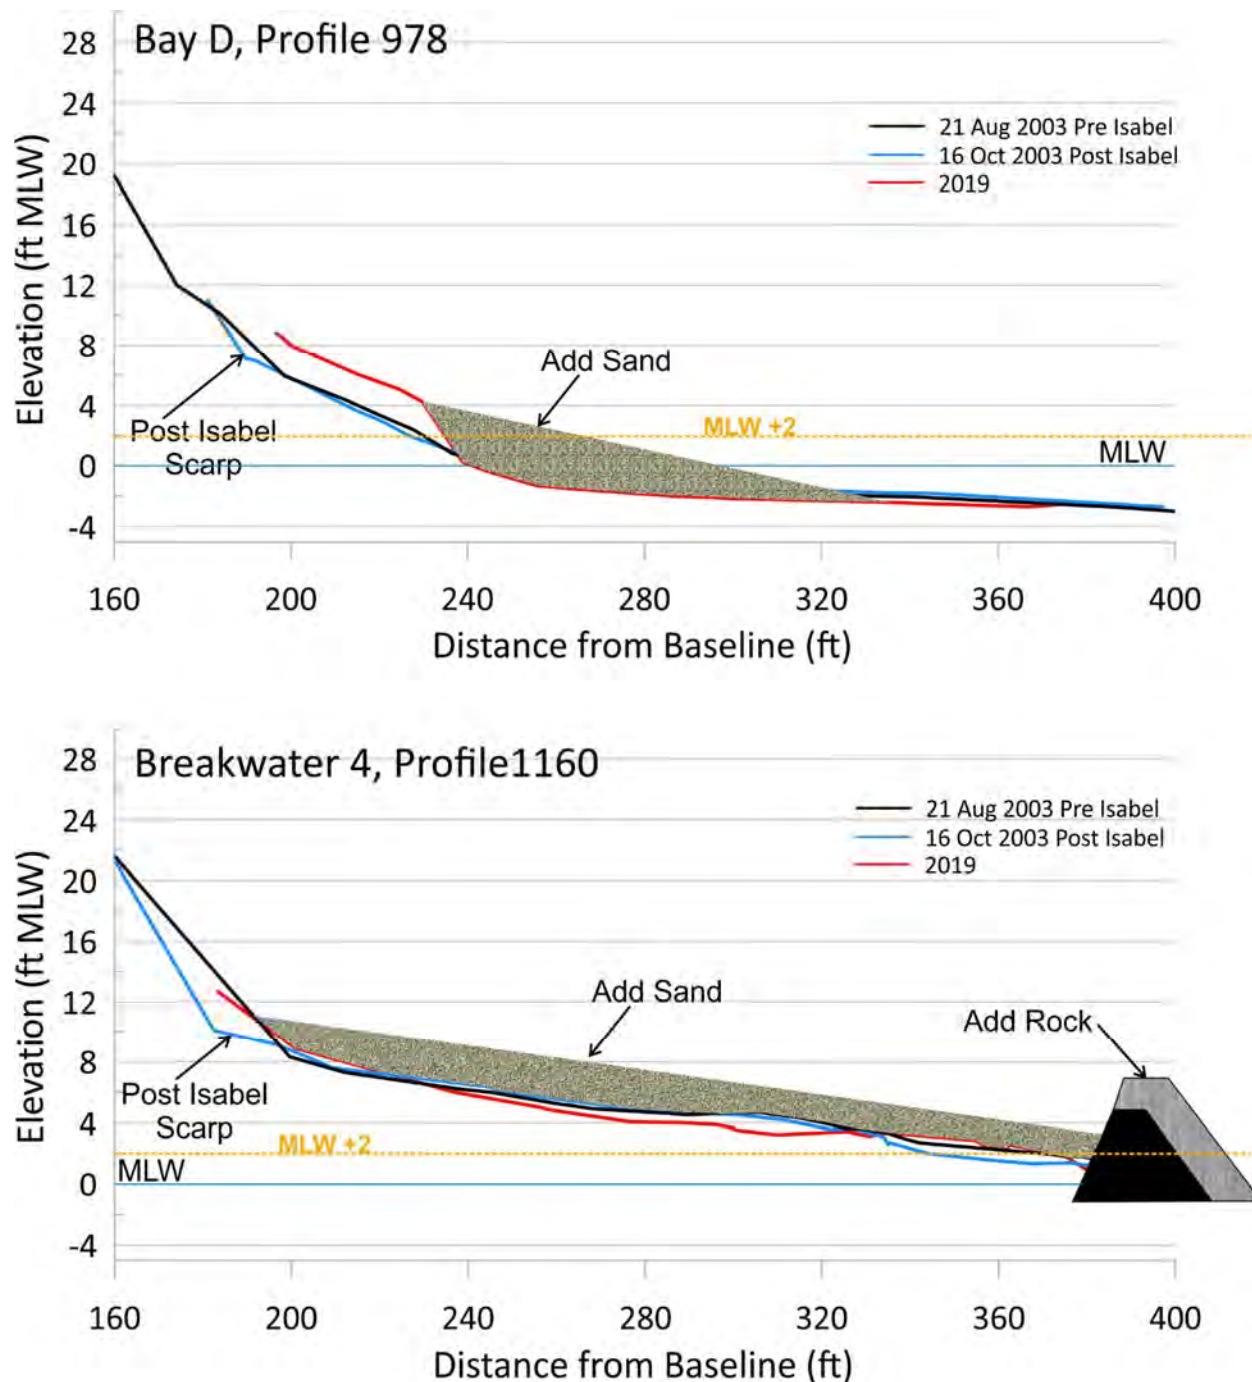
Figure 5-4. Selected cross-sectional profiles of survey data taken at Kingsmill in 2003, pre and post Hurricane Isabel and 2019. The +2 ft MLW depicts the SLR scenario. Rock and sand can be added to the system to adapt to rising sea level to ensure resiliency of the overall system.

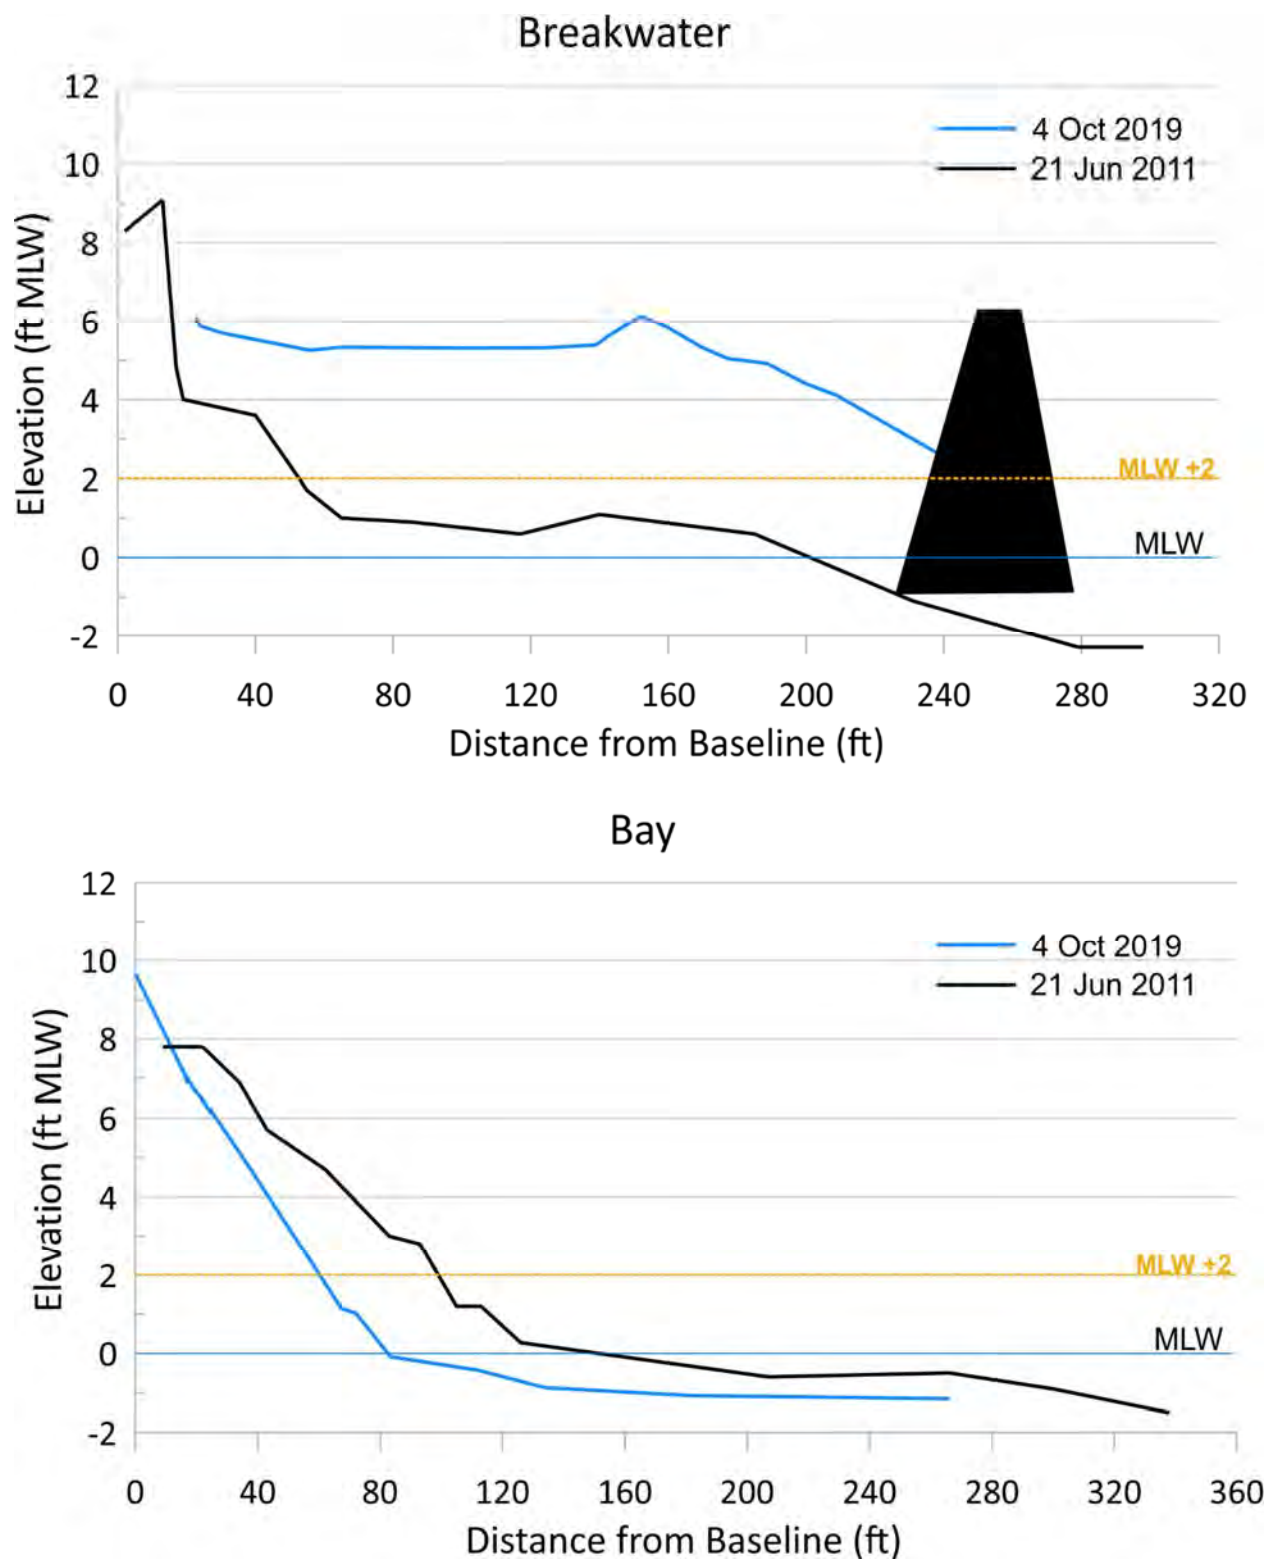
Figure 5-5. Selected cross-sectional profiles of survey data taken at Bavon in 2011 and 2019. The +2 ft MLW depicts the SLR scenario. 2011 survey data provided by VHB, Inc.

At this stage, the Bavon Beach breakwater system is still evolving (Figure 5-5). Access to Bavon will be an issue in the future as sea level rises, because the road to the subdivision now frequently floods during spring tides. Unless the access issue is resolved any adaptive management options may not be available. Though not modeled, rock and sand could be added to adapt to SLR. As noted earlier, the bay profile shows erosion between 2011 and 2019 even though sand was placed along the shoreline in 2016. The shoreline eroded significantly between 2011 and 2016. As shown in Figure 4-5-3, the southern section of the Bavon reach has had a great deal of beach and dune loss since monitoring of the site began in 2001. With the placement of the structures, the sand has evolved to a dynamic equilibrium and should maintain its shape.
